Contract #: 04-0120F4Cty: SF/ALA Rte: 80 PM: 13.2/13.9File #: 69.28**WELDING INSPECTION REPORT****Resident Engineer:**Pursell, Gary**Address:** 333 Burma Road**City:** Oakland, CA 94607**Report No:** WIR-015910**Date Inspected:** 24-Jul-2010**Project Name:** SAS Superstructure**OSM Arrival Time:** 700**Prime Contractor:** American Bridge/Fluor Enterprises, a JV**OSM Departure Time:** 1900**Contractor:** Zhenhua Port Machinery Company, Ltd (ZPMC), Changxing Island **Location:** Shanghai, China**CWI Name:** N/a**CWI Present:** Yes No**Inspected CWI report:** Yes No N/A**Rod Oven in Use:** Yes No N/A**Electrode to specification:** Yes No N/A**Weld Procedures Followed:** Yes No N/A**Qualified Welders:** Yes No N/A**Verified Joint Fit-up:** Yes No N/A**Approved Drawings:** Yes No N/A**Approved WPS:** Yes No N/A**Delayed / Cancelled:** Yes No N/A**Bridge No:** 34-0006**Component:** OBG Trial Assembly**Summary of Items Observed:**

Orthotropic Box Girder (OBG) Trial Assembly Areas

WELDING INSPECTION REPORT

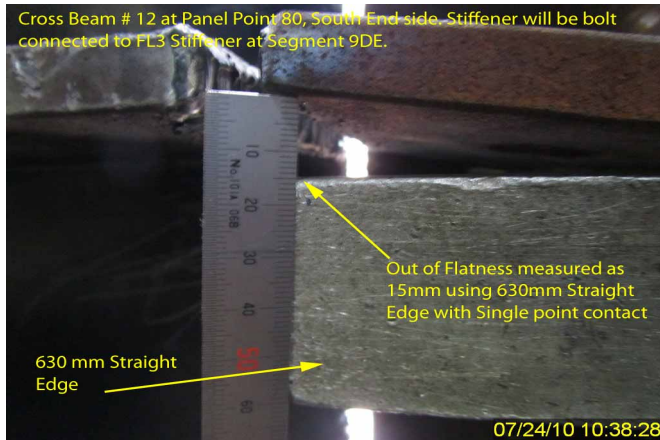
Incident Report generated at Cross Beam # 12

This Quality Assurance (QA) Inspector wrote an Incident Report for a Stiffener being out of flatness. The Stiffener was identified as the 6th from the bottom plate at the south end of the Cross Beam at Panel Point (PP) 80. Please reference the Incident Report # 04-0120F4_TL-15_B278_07-24-2010_CB 12_PP 80_Stiffener_Out of Flatness dated July 24, 2010.

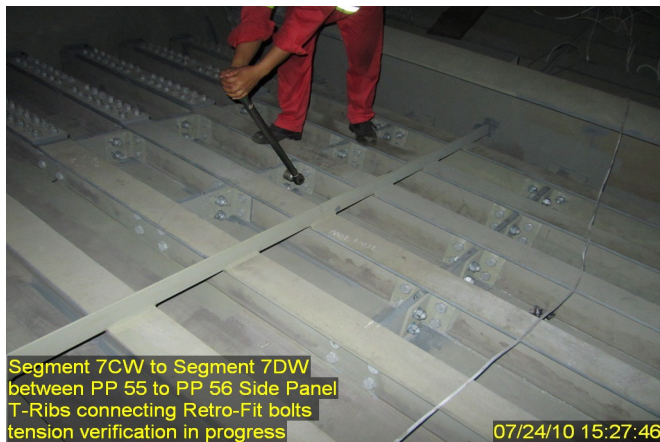
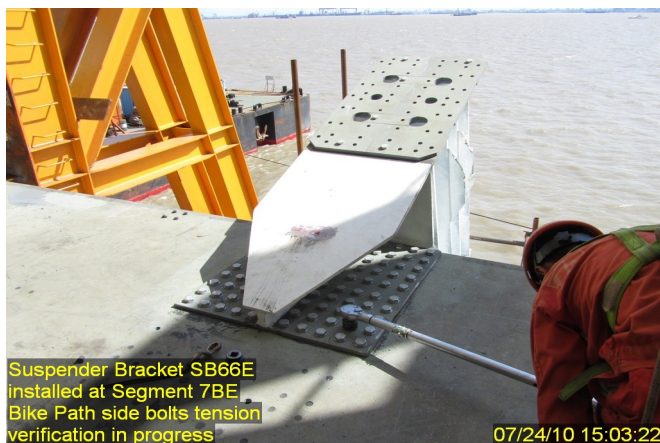
Segment 7CW to Segment 7DW

This QA Inspector witnessed the final bolt tension verification on bolts connecting Retro-fit to Side panel T-Ribs and Retro-fit connecting to Longitudinal Diaphragm between Panel Points (PP) 55 to PP 56 for Segment 7CW to Segment 7DW at Cross Beam side. The QA Inspector verified the bolt tension on a random basis and the results appeared to be in general compliance. The Inspection was performed against Notification No. 00438 dated July 24, 2010.

The manual torque wrench used to verify tension was S/N XO-747. Please reference the pictures attached for more comprehensive details.
